## How to Replace the ‘Rate Monitor’ of the Prestan Professional Manikin

### **Replacing the 'Rate Monitor' (Continued)**

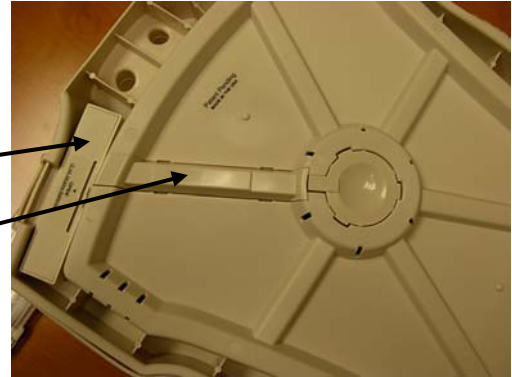
Figure #1

- Turn the manikin over so that the chest of the manikin is down and the back of the manikin is facing you. Note the 2 parts shown in Figure #1.

**Rate Monitor**

**Wire Cover**

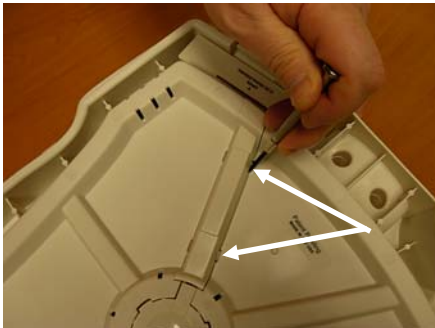
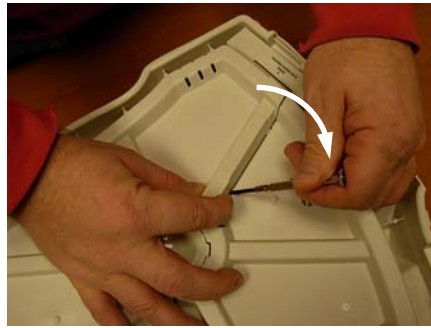
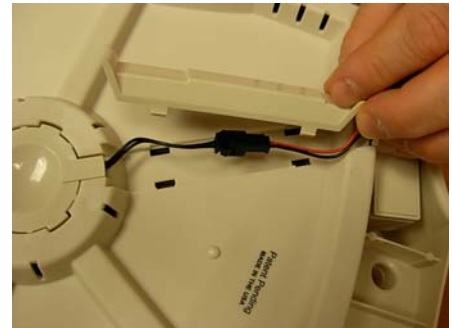
Figure #2

- **1) Remove the Wire Cover** – There are four snap tabs, two on each side of the Wire Cover. Using a small, slotted screwdriver, press in and lift up on two tabs along the same side of the Wire Cover. (fig. #2, #3 & #4)

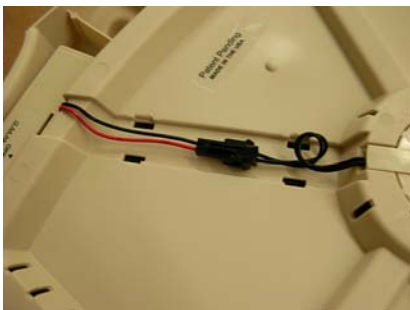
Figure #5

- **2) Disconnect the Wires** – Once the Wire Cover is removed, you will see wires from the Rate Monitor leading to a black Connector in the middle. (fig.#5) Squeeze the small latch on the Monitor side of the Connector (fig.#6) and pull the two halves apart.(fig.#7)

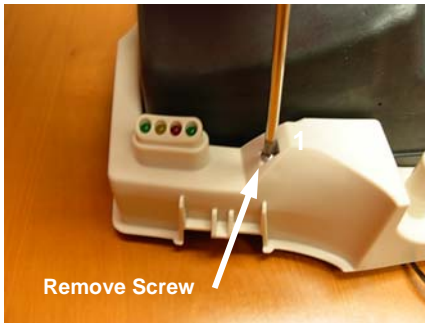
Figure #8

- **3) Remove the Old Monitor** : Turn the Manikin right side up and remove the Philips screw as shown in figure # 8. Remove the Monitor from the underside of the shoulder as shown in figure # 9.
- **4) Install the New Monitor** : Hold the new Monitor up inside the shoulder and reinstall the screw. (fig.#10)

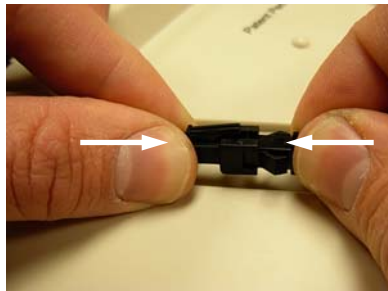
Figure #11

- **5) Re-connect the Wires and Replace the Wire Cover** – Align the Connectors and press them together. Make sure you hear a click. (fig.# 11) Align wires down the center of channel for the Wire Cover. If needed, make a loop with any excess wire. (fig.#12) Snap the Wire Cover into place by pressing firmly over 4 snaps (fig.#13)
